FINAL REPORT OF PHASE II

HIGH SHOCK FM TRANSMITTER

CONTRACT NUMBER NAS1-5042

14 MAY 1966

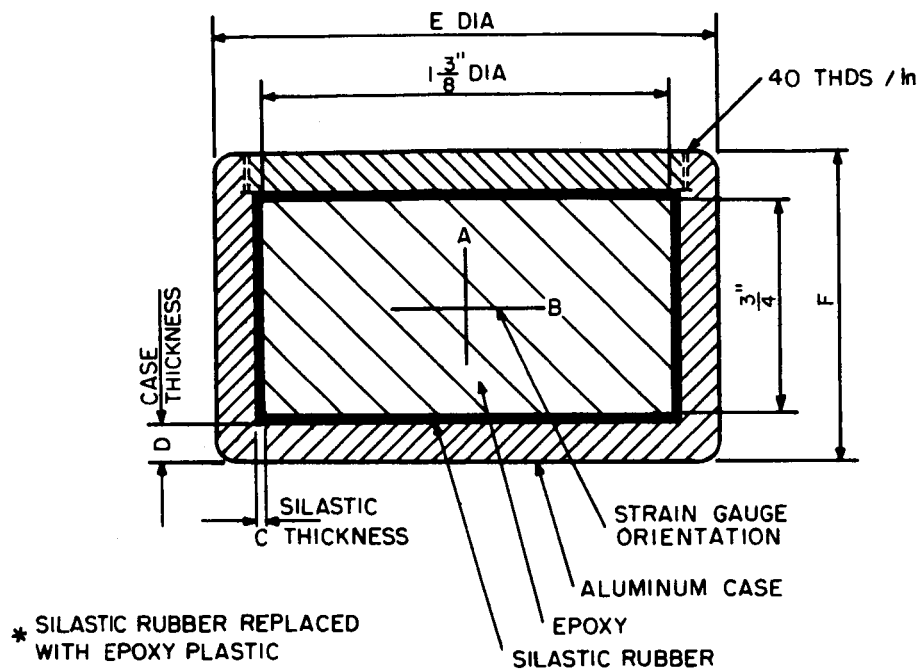
CONFIGURATION NO.	DIMENSION "D" (CASE THICKNESS) INCHES	DIMENSION "C" (SILASTIC THICKNESS) INCHES	CASE DIMENSIONS INCHES	
			E	F
4A	$\frac{1}{8}$	$\frac{1}{16}$	$1\frac{3}{4}$	$1\frac{1}{8}$
5A	$\frac{1}{8}$	$\frac{1}{32}$	$1\frac{11}{16}$	$1\frac{1}{16}$
6A	$\frac{1}{8}$	$\frac{1}{64}$	$1\frac{21}{32}$	$1\frac{1}{32}$
4B	$\frac{1}{16}$	$\frac{1}{16}$	$1\frac{5}{8}$	1
5B	$\frac{1}{16}$	$\frac{1}{32}$	$1\frac{9}{16}$	$1\frac{15}{16}$
6C	$\frac{1}{16}$	NO SILASTIC *	$1\frac{17}{32}$	$1\frac{28}{32}$

Figure 1. Mechanical Evaluation of Double Wall Case Design

4 Three dummy transmitter cases were produced to evaluate the effectiveness of various silastic and outer transmitter case thicknesses. Two strain gauges were applied to a copper-clad fibreboard chassis similar to the actual transmitter chassis. The strain gauges were oriented perpendicular to each other; one parallel to the cylindrical or A-axis of the transmitter and the other parallel to a diameter. They were then potted in Stycast 1090 plastic and machined to 1 3/8 inch overall diameter by 3/4 inch in length. The addition of Dow Corning 501 silastic and high strength aluminum cases completed the test configurations. The dimensions of the test configurations used are given in Figure 1. Numbers 4A, 5A and 6A were tested and then machined to produce configurations 4B and 5B. After the initial tests on 6A the strain gauge module was removed and repotted with Stycast 1090 into the aluminum case, becoming 6C. The directions of the loads applied coincide with the direction of the potted strain gauges. The thin fibreboard chassis, to which the gauges were bonded, was assumed to carry negligible load. The results of these tests are shown in Figures 2, 3 and 4.

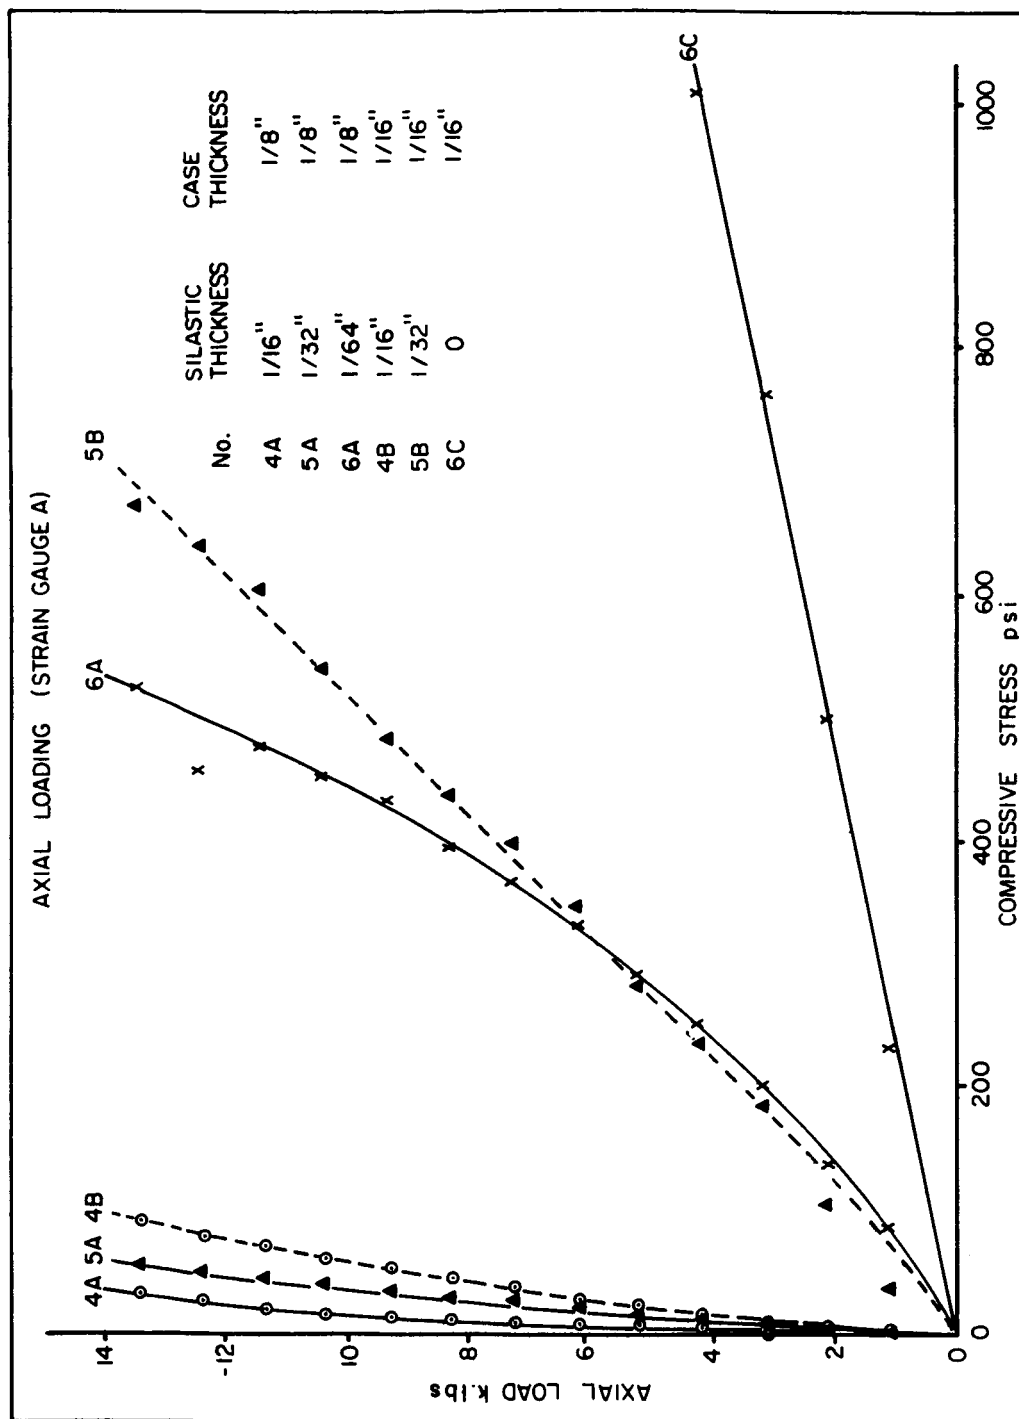
Figure 2. Compression Test Results on Double Wall Transmitter Case

6 When the 1/16 inch thick cases were loaded parallel to a diameter, buckling of the ends was observed. As the ends would be supported laterally when in the fibreglass test ball, this mode of failure should be eliminated. Thus there should be less difference between the 1/6 inch case and 1/8 inch case in the ball, than is indicated by the compression test. The 5B unit was encapsulated into a 3.5 inch reinforced epoxy ball. Dynamic strain in the dummy transmitter during impact on the concrete target was measured and the results are indicated in a later section.

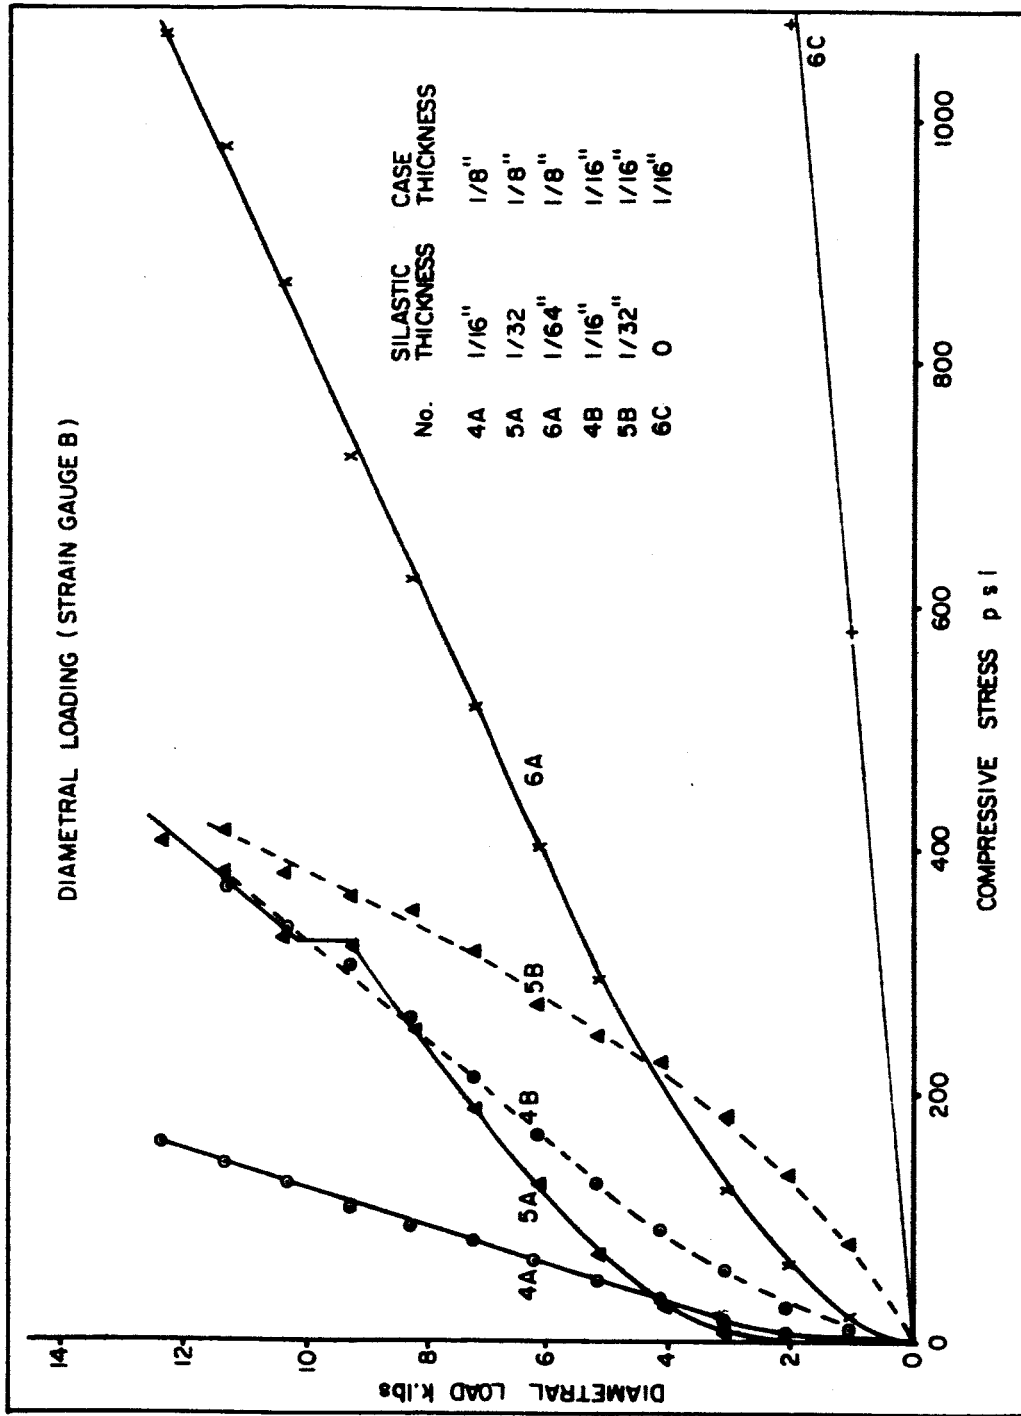
Figure 3. Compression Test Results on Double Wall Transmitter Case

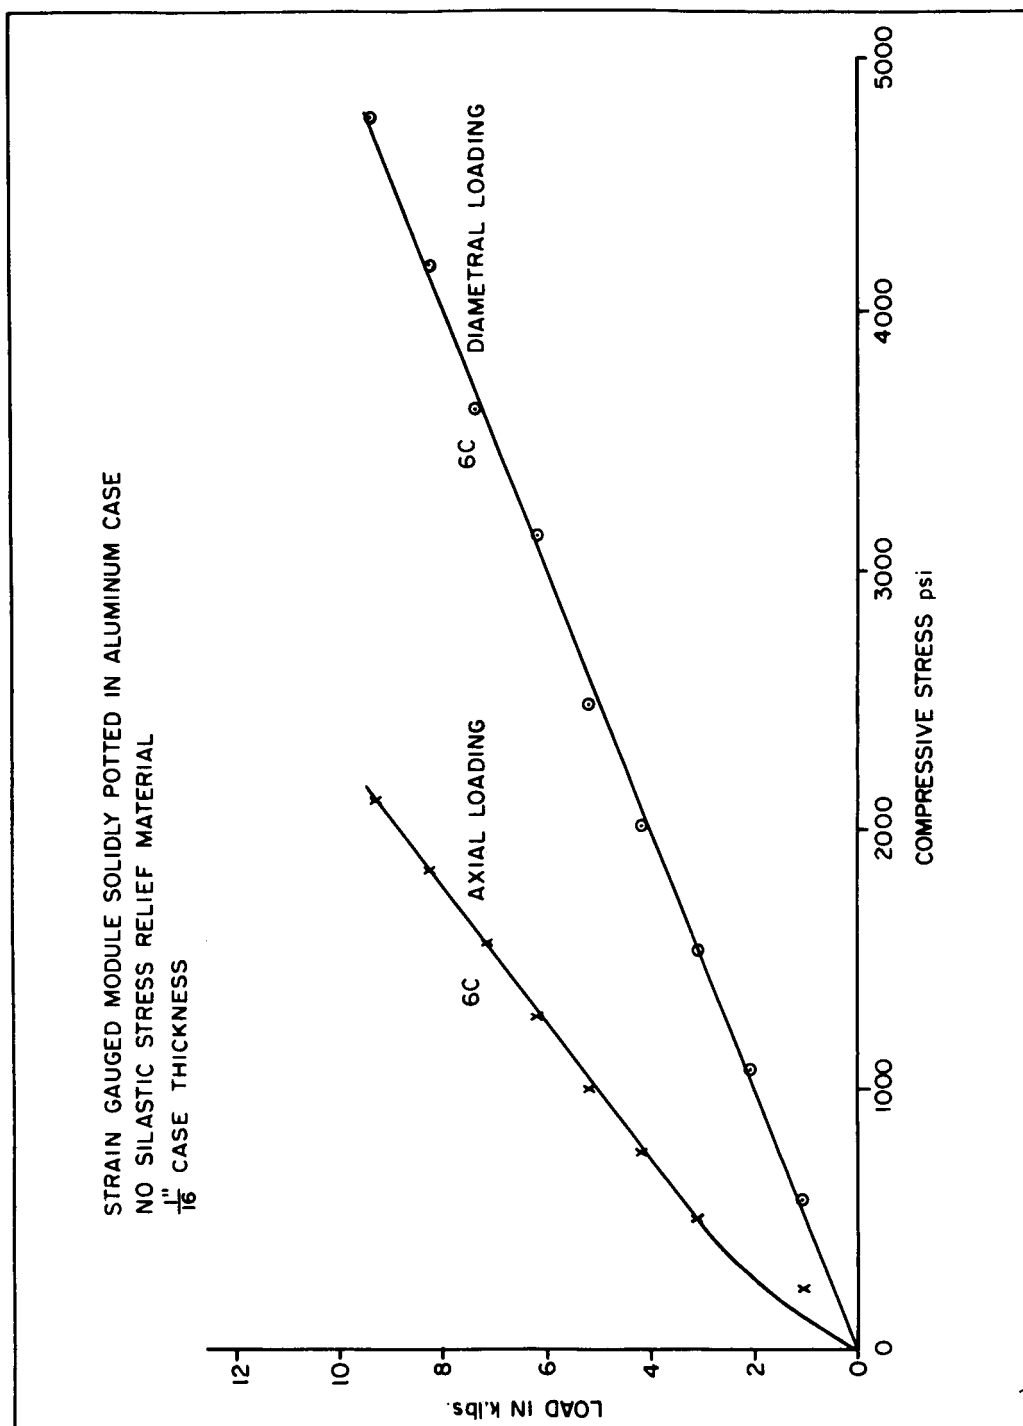
Figure 4. Compression Test Results on Double Wall Transmitter Case

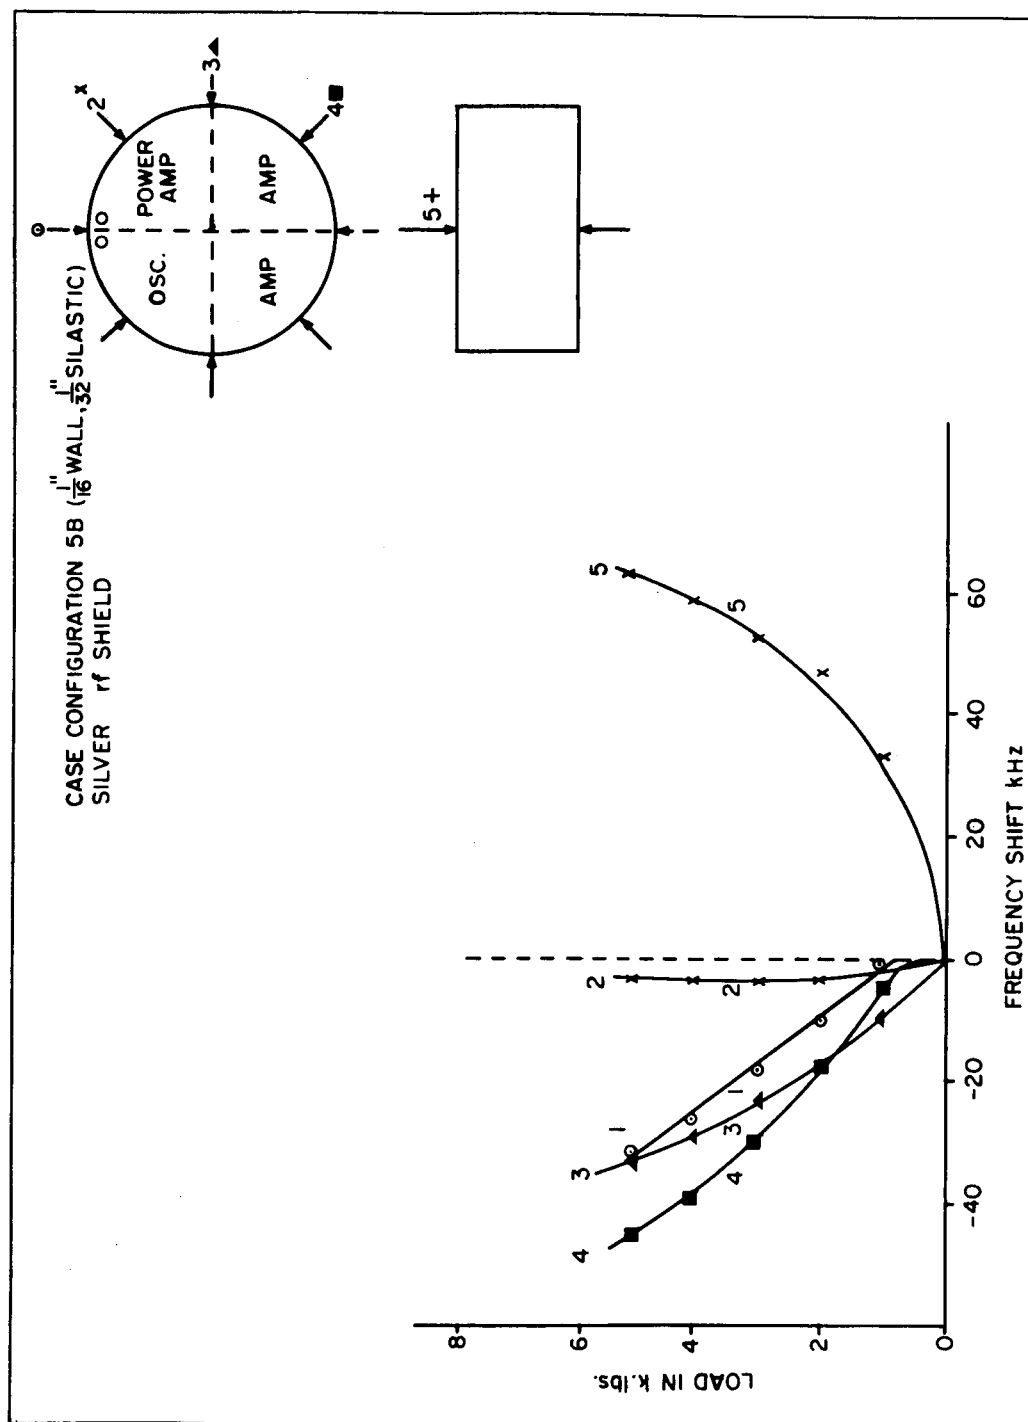
Figure 5. Compression Test Results on Phase II Prototype Transmitter

7 Compression tests on two of the above configurations were conducted using the Phase II prototype transmitter. The first case was similar to configuration 5B and, as seen in Figure 5, a maximum frequency shift of -45 kHz was observed when the case was diametrically loaded to 5000 pounds and +62 kHz when loaded axially with the same load. The load was limited to 5000 pounds because the case began to fail by buckling at its ends. The transmitter was then removed from the 1/16 inch thick case and repotted into a 1/8 inch case with a 1/32 inch thickness of silastic. This configuration is similar to 5A in Figures 2 and 3. Compression tests on this unit are shown in Figure 6 and indicate a maximum frequency shift of +18 kHz and -18 kHz for a 10,000 pound load in the diametrical and axial directions respectively. As mentioned earlier the 1/16 inch thick case was likely to show greater changes than the 1/8 inch because of buckling of the unsupported walls.

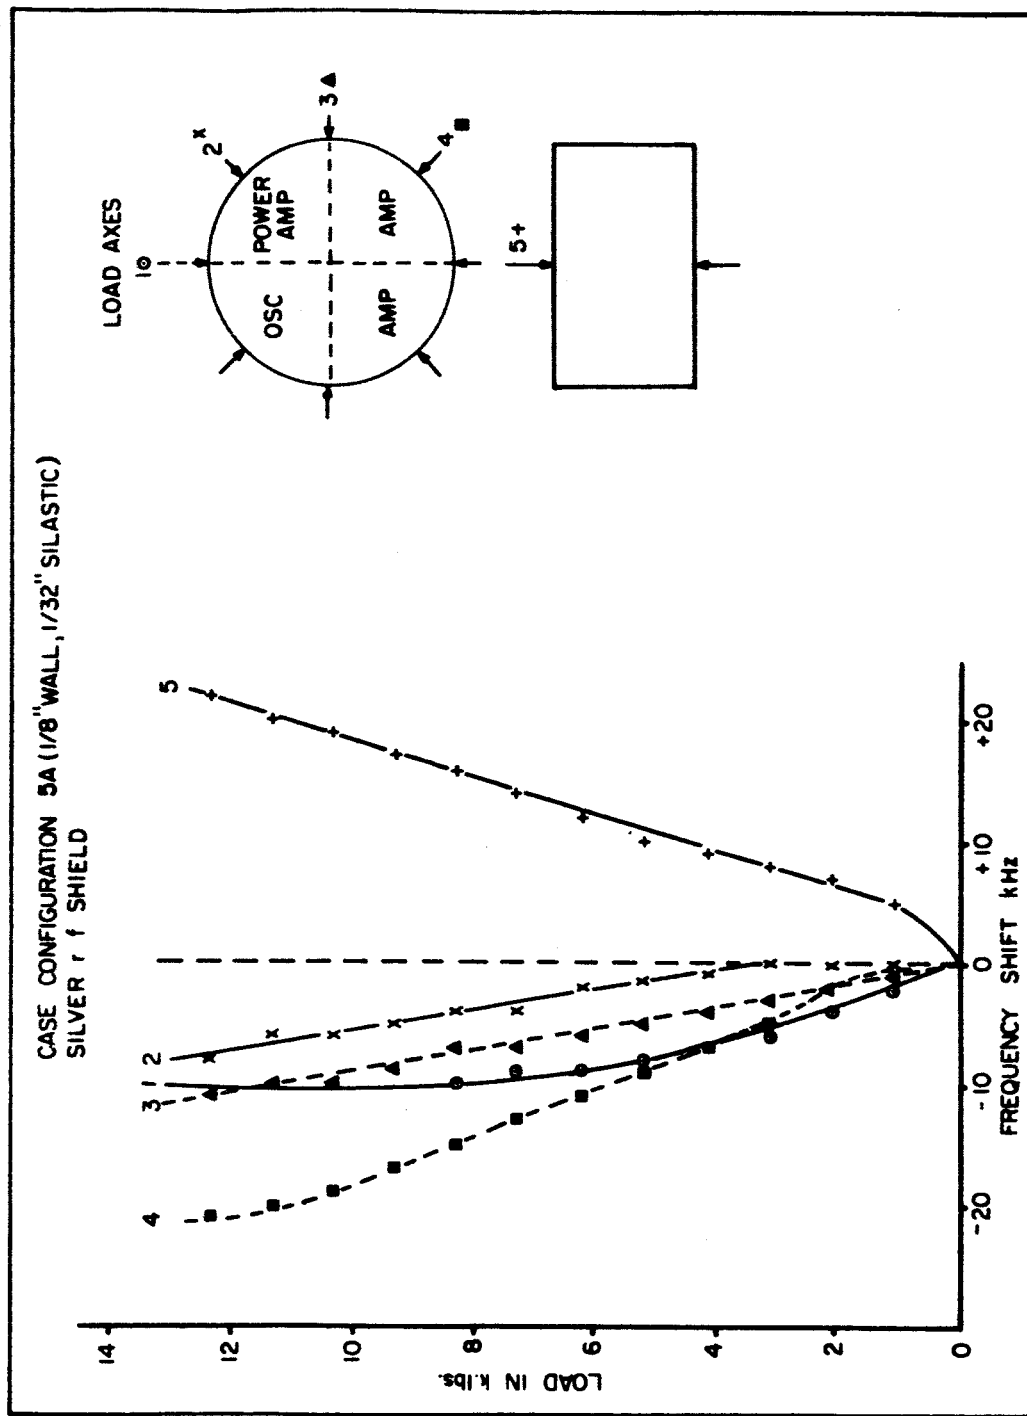
Figure 6. Compression Test Results on Phase II Prototype Transmitter

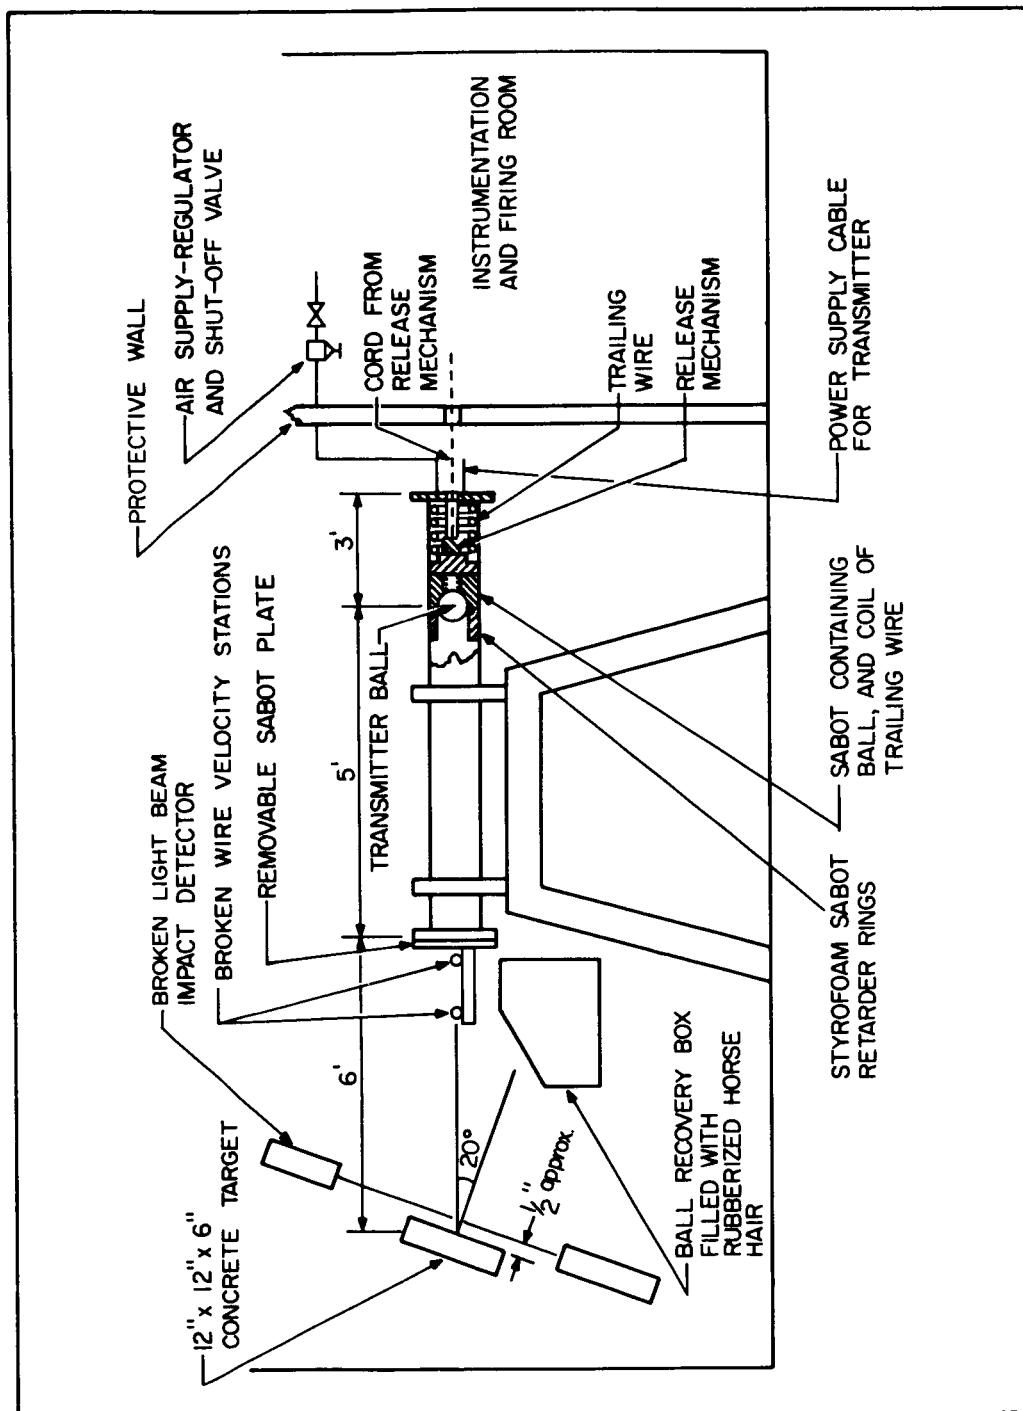
Figure 7. Computing Devices' Compressed Air Launcher

4 The velocity of the ball is measured by two break-wire stations one foot apart. To obtain a trigger for initiating oscilloscope sweeps just before impact, a simple broken-beam light screen detector has been mounted one half inch in front of the target.

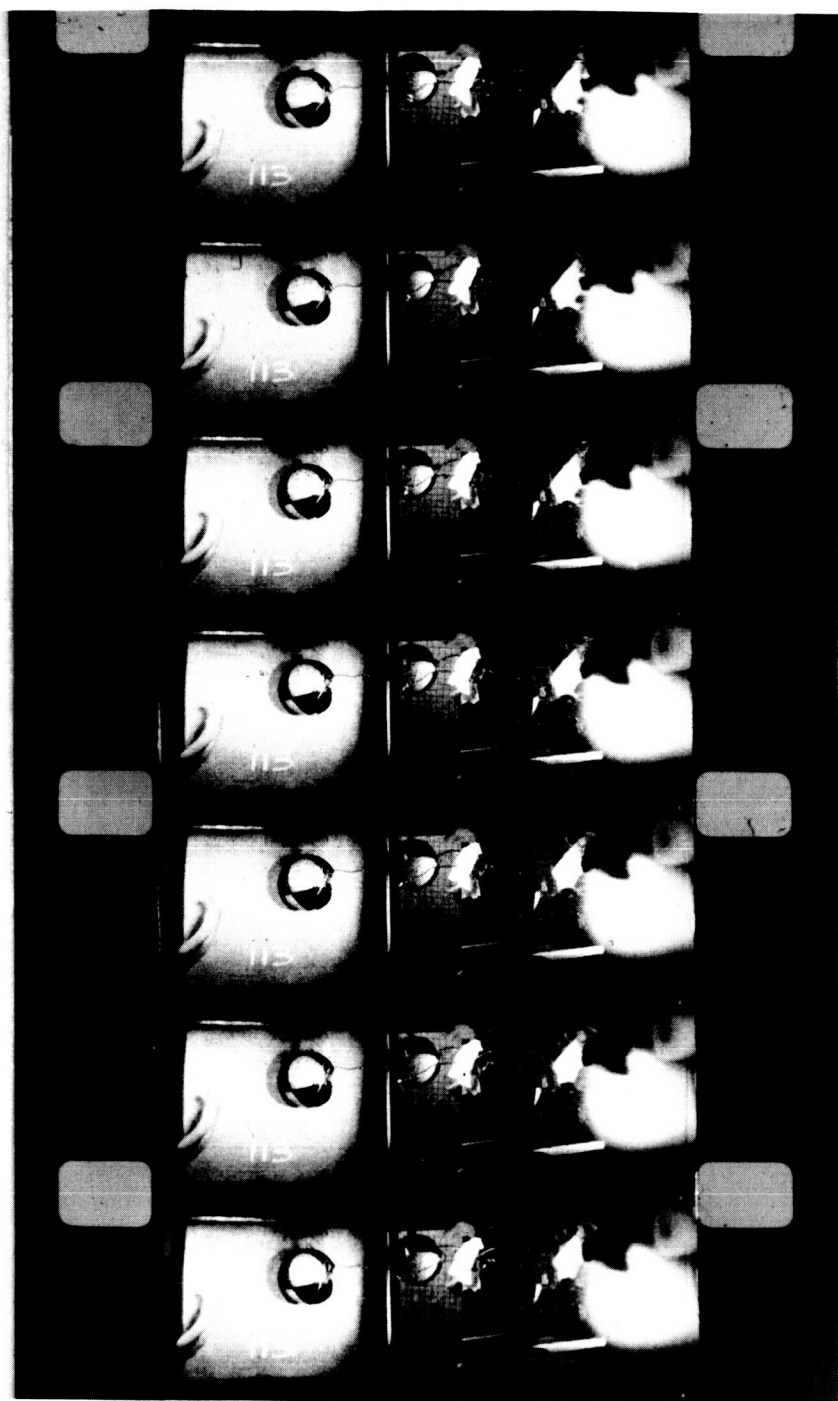
Figure 8. Fastax Photograph Showing Impact of Test Sphere into Concrete Target

11 A high framing-rate camera (Fastax) was used to make in-flight photographs of the ball and trailing wires. The sequence shown in Figure 8 was taken from one of the filmings. The framing rate was 7,680 frames per second and projectile velocity was 113 feet per second. Two mirrors were used to improve the information content of the pictures. The first mirror, just to the right of the target was adjusted so that the ball was viewed at right angles to its trajectory as it impacted on the target. The thin white line in this mirror represents the entire surface of the target. To the right of the first mirror is a second mirror which provides a view of the gun muzzle.

12 The photographs confirm the short impact time measured by the strain gauges. The ball appears to be in contact with the target for less than 0.5 milliseconds. A dimension change across the diameter of the ball parallel to the surface of the target is difficult to detect.

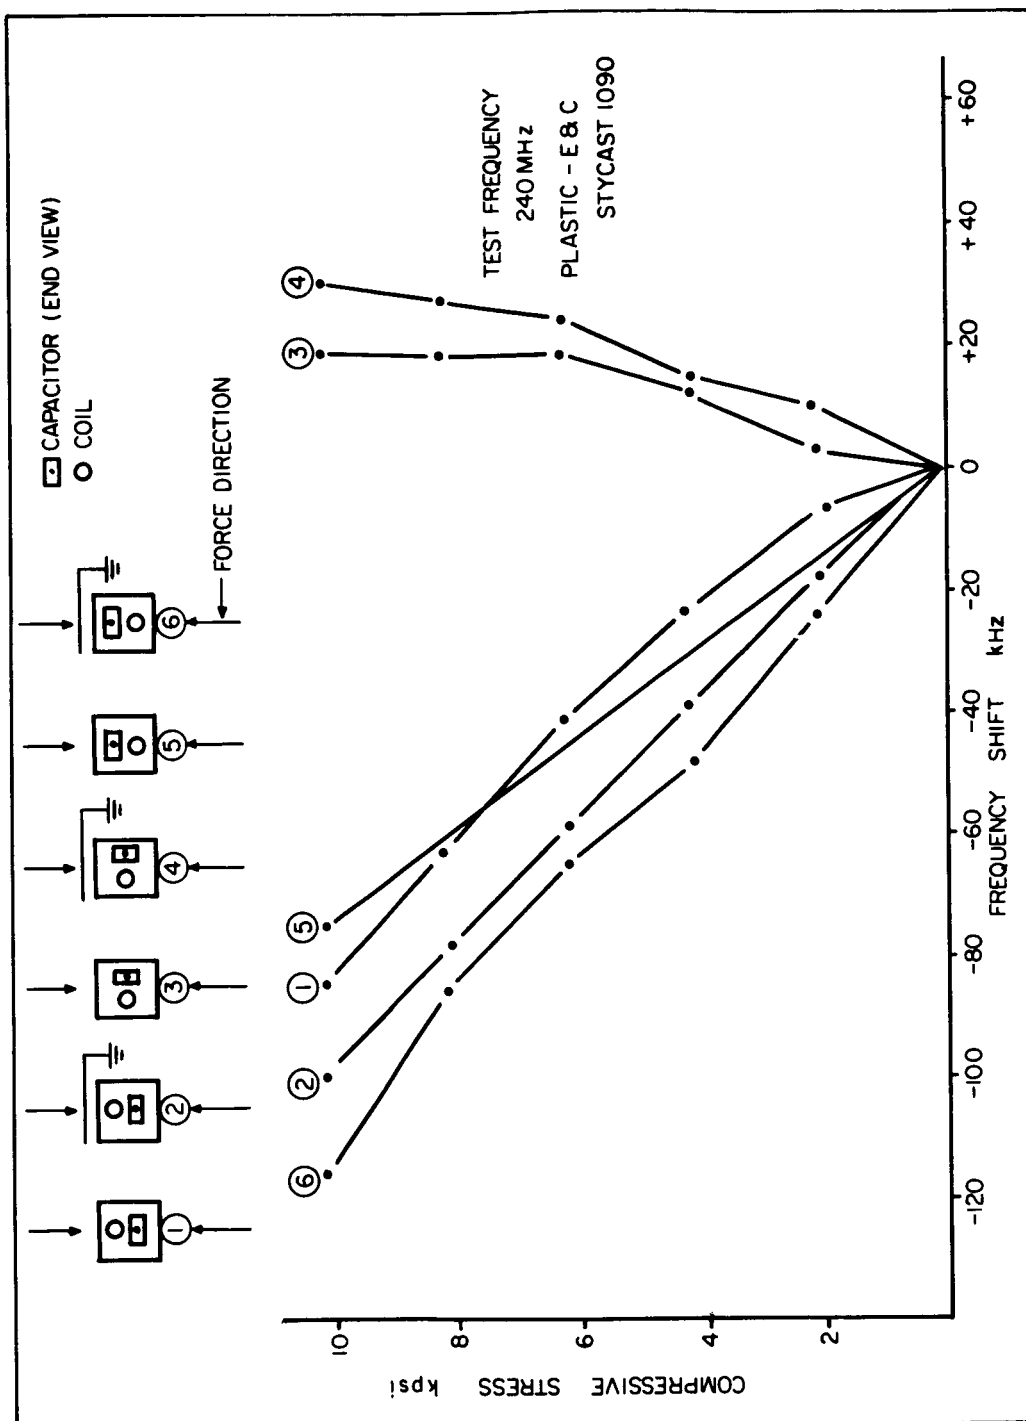
Figure 9. Compression Tests on R.F. Components

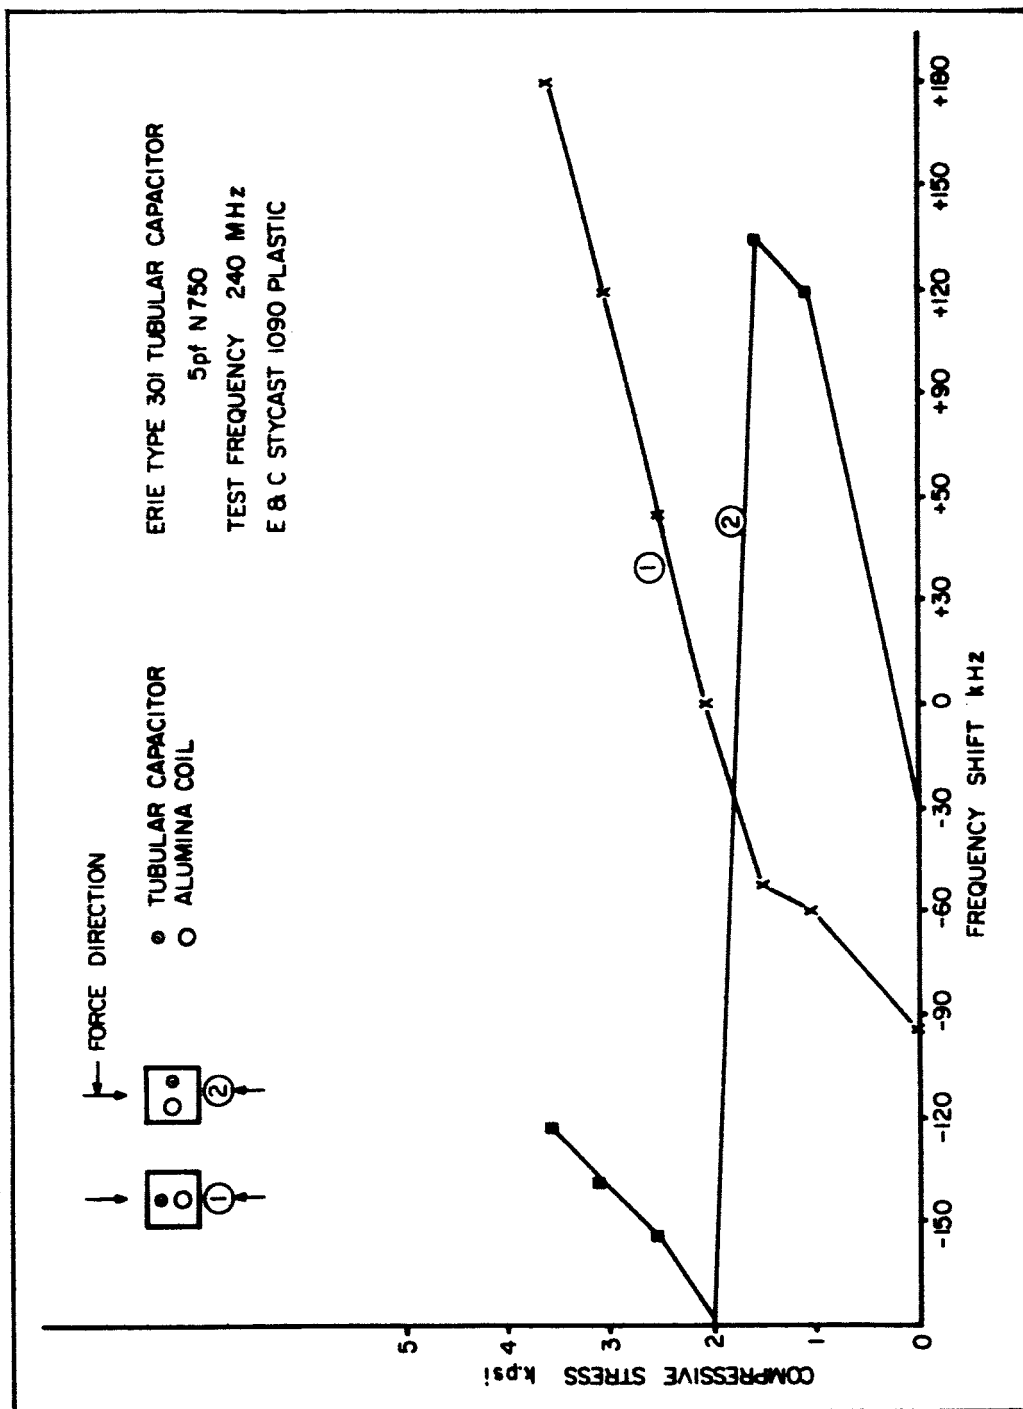
Figure 10. Compression Tests on R.F. Components

4 Figure 10 gives the results obtained using a similar coil but with the Erie type 301 (N750) tubular temperature compensating capacitors. Large changes in frequency occurred. These capacitors were used in the Phase II prototype transmitter and may account for some of the frequency shift. Figure 11 shows the results obtained using Erie disc capacitors. These units are considerably better. Comparing Figures 9 and 11 it is seen that the frequency change for the disc capacitor is of opposite sign to that of the Corning unit. Figure 12 gives the results of the alumina coil alone.

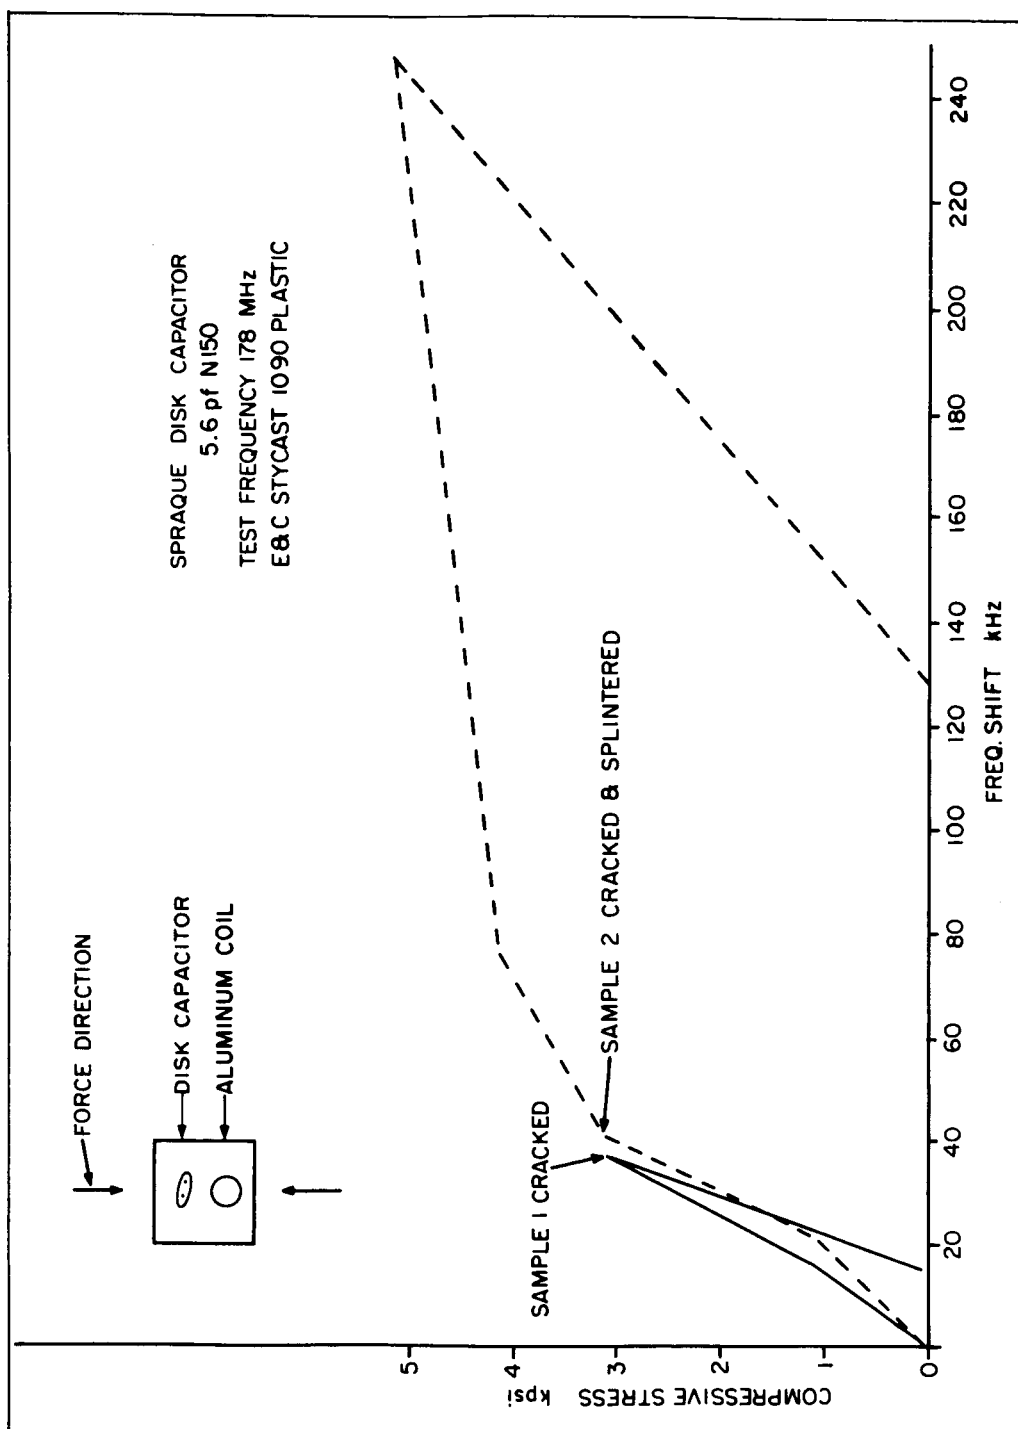
Figure 11. Compression Tests on R.F. Components

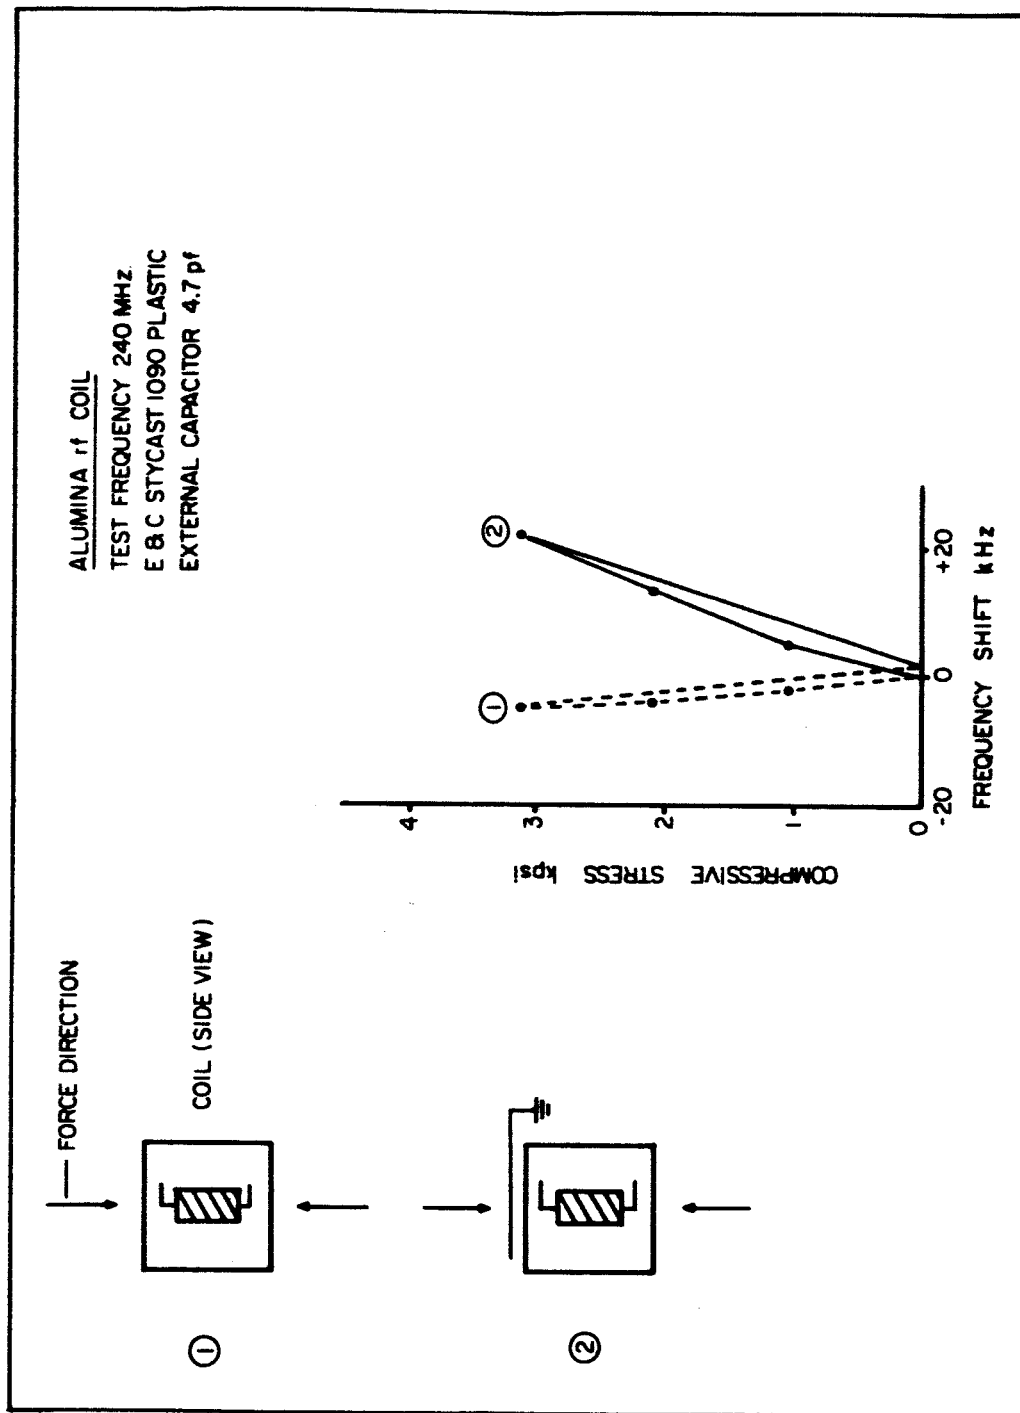
Figure 12. Compression Tests on R.F. Components

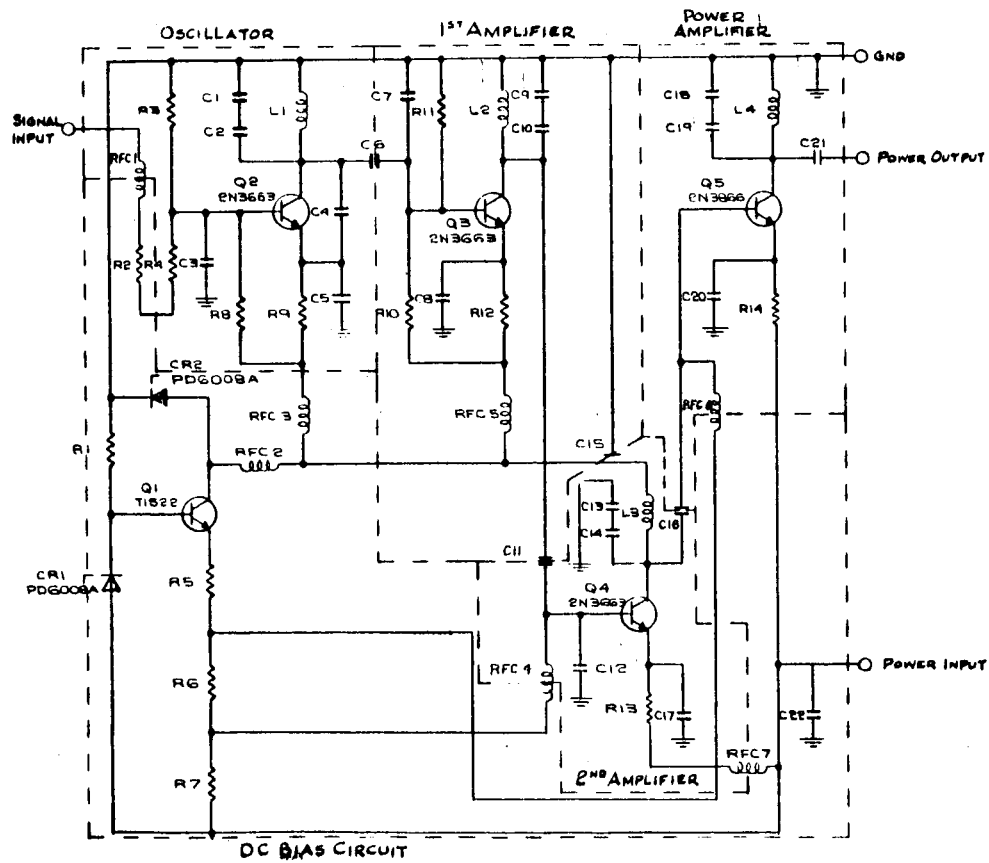
Figure 13. High Shock FM Transmitter Circuit Diagram

6 Current for CR2, the oscillator and the first amplifier is provided by Q1 and Q4. These are constant current sources because the base potential of Q1 is held at a constant 5.5 volts above the negative potential by the zener diode CR1. The constant emitter current of Q1 provides a constant voltage drop across R6 and R7 to provide a constant base potential for Q4 and the power amplifier transistor, Q5.

10 The oscillator is tuned by the series capacitors C1 and C2. C2 is a temperature compensating capacitor. The oscillator is loosely coupled through C6 into the first amplifier. The oscillator output at this point is approximately half a milliwatt into a 50 ohm load.

14 A 2N3866 transistor is used in the power amplifier because of the large power dissipation which occurs in this stage. The circuit is similar to the one used in the previous two amplifiers. The minimum power output through C21 is 100 milliwatts into a 50 ohm load.

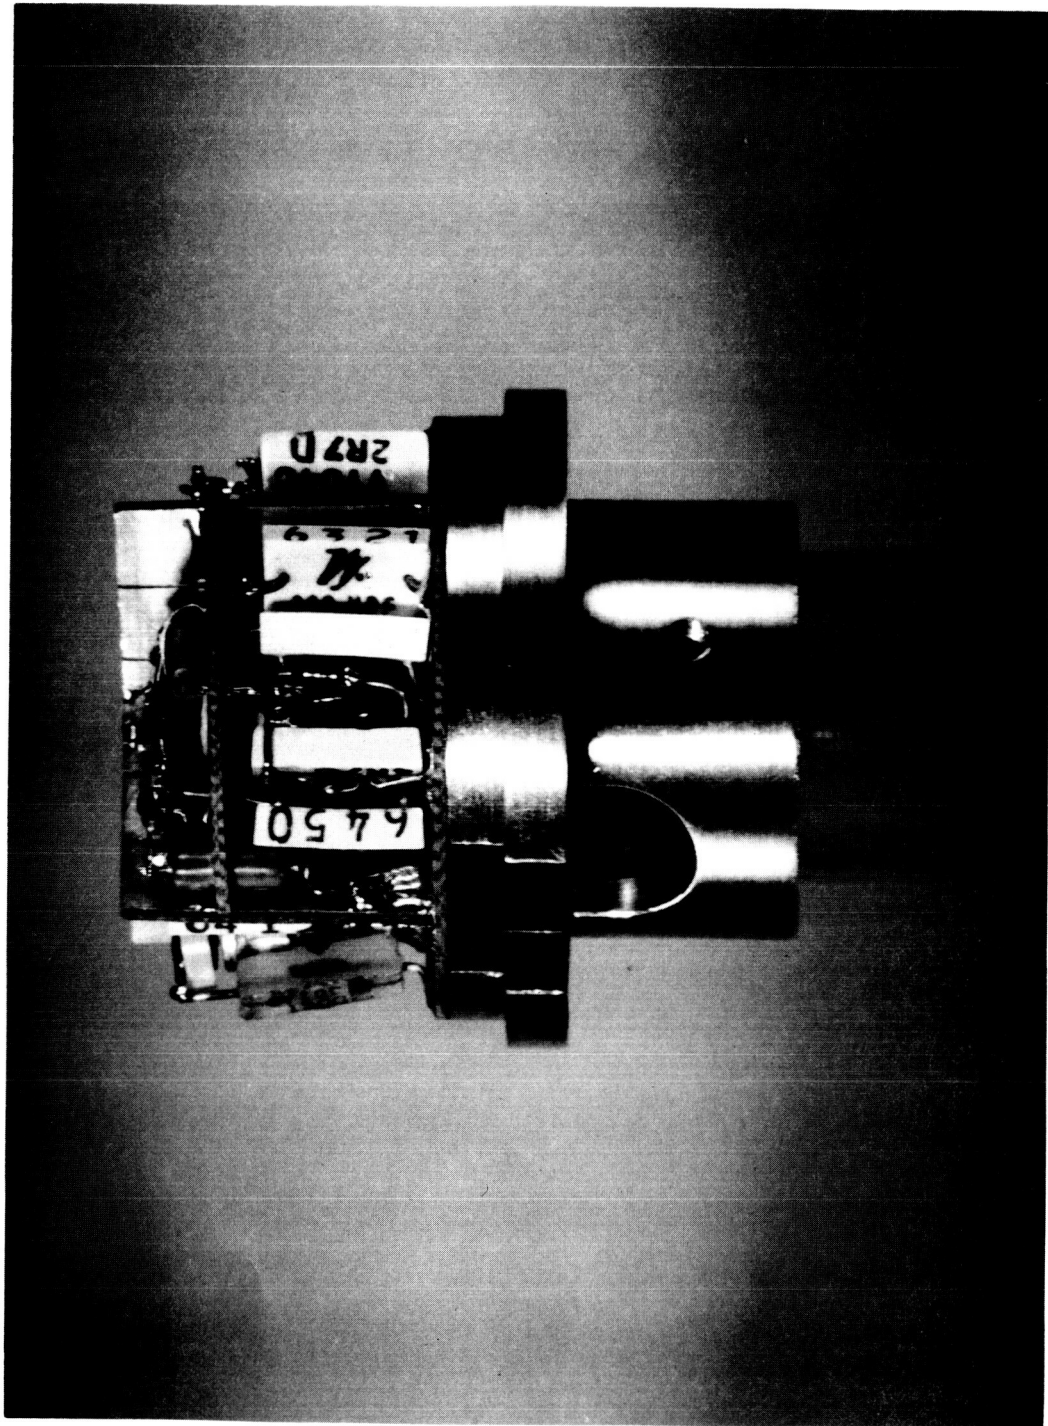
Figure 15. Photograph Showing Oscillator and D.C. Bias Circuit in Unpotted Transmitter

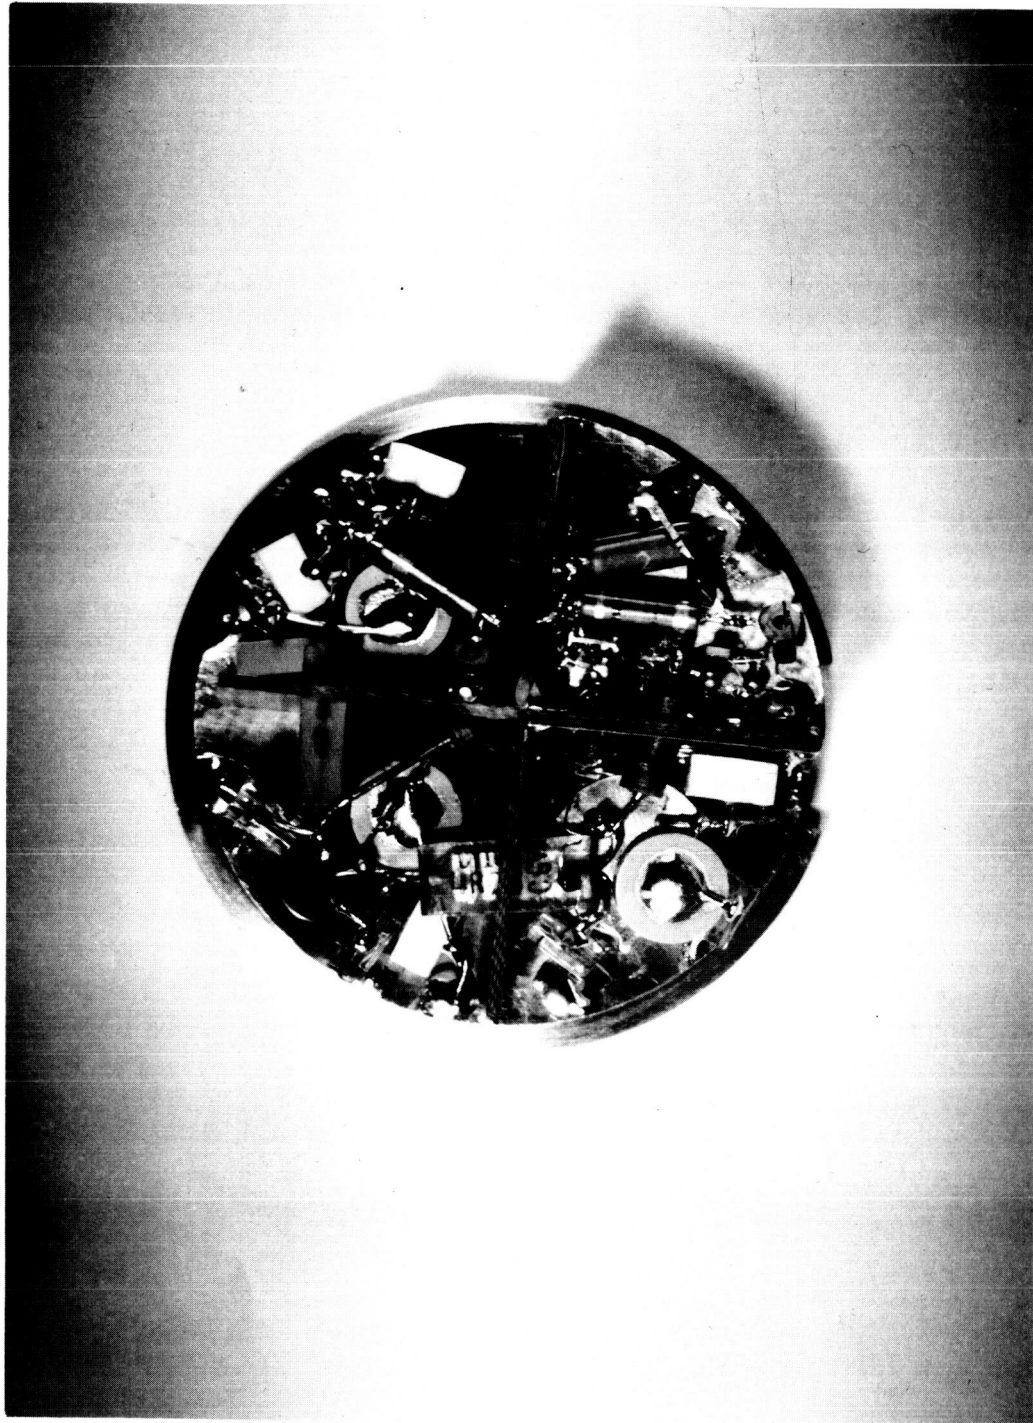
Figure 16. Photograph Showing Top View of Unpotted Transmitter
